# CARNEGIE INSTITUTE OF TECHNOLOGY

## STRESS CORROSION CRACKING OF SINGLE CRYSTALS OF SOME AUSTENITIC STAINLESS STEELS

1 October 1960

CONTRACT Nonr 760 (14) NR 036-029

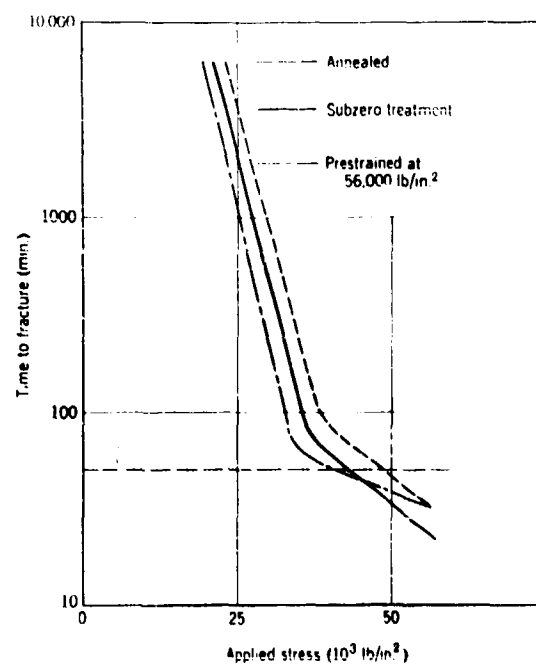
Figure 1. Variation of Time to Fracture with Applied Stress. Steel 18-8: fully softened; prestrained at 56,000 psi; and refrigerated at  $-184^{\circ}\text{C}$  for 1/2 hour. Tested at  $152-153^{\circ}\text{C}$  (13).

A large amount of experimentation has been done on the stress corrosion cracking of polycrystalline austenitic stainless steels. The effect of stress upon the time to fracture in polycrystalline 18-8 material in boiling 42% MgCl<sub>2</sub> solution is generally reported in the form of figure 1.<sup>(13)</sup> A threshold stress for stress corrosion is difficult to measure. For reasonable experimental times, say of order 10,000 minutes, reported threshold stresses vary from zero applied stress to the yield stress.

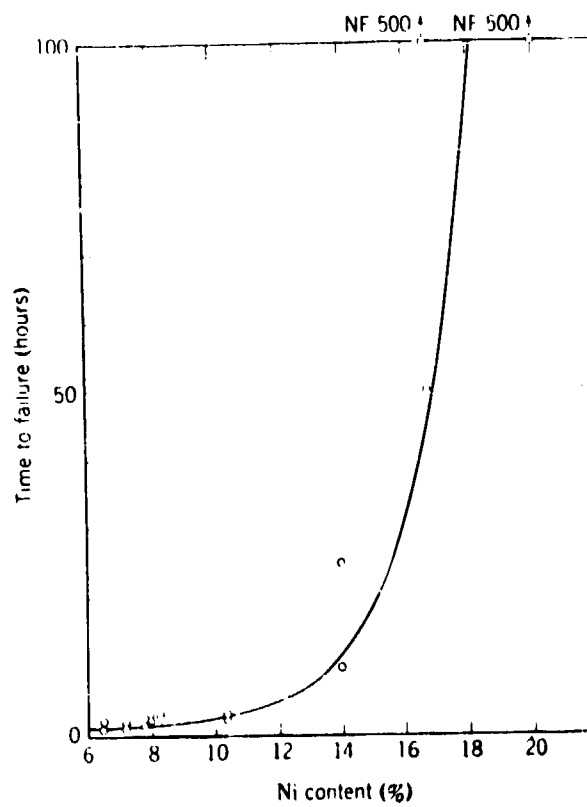
Figure 2. Time to failure of steels with 17-18% Cr and with various nickel contents. Tests were conducted in boiling 42%  $\text{MgCl}_2$  on 0.1685 inch tensile specimens stressed to 40,000 psi (Nominal)(14).

The effect of nickel composition upon the time to failure in boiling 42% MgCl<sub>2</sub> has been reported by Edeleanu<sup>(14)</sup> in the form shown by figure 2. These data indicate that 18% is needed in a Fe-18% Cr alloy to prevent stress corrosion failure in 100 hours. Copson<sup>(15)</sup> has reported that roughly 42% Ni is needed to prevent failure in 100 hours. This is typical of the scatter found in the stress corrosion literature.

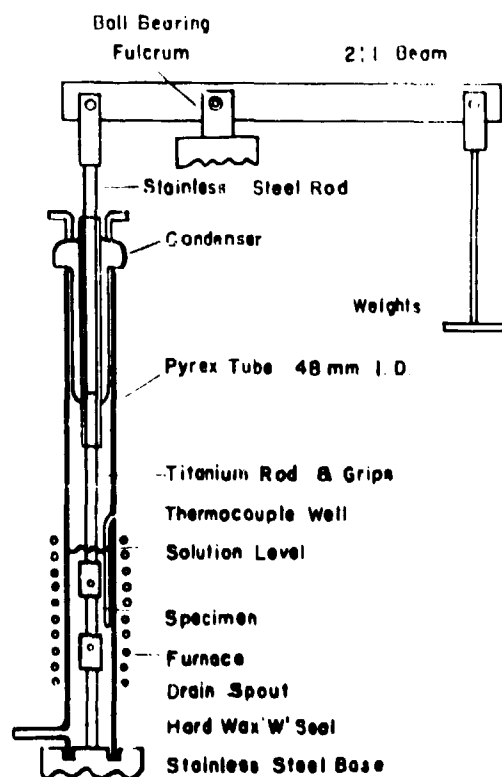
Figure 3. Schematic Drawing of Apparatus for Stress Corrosion Testing.

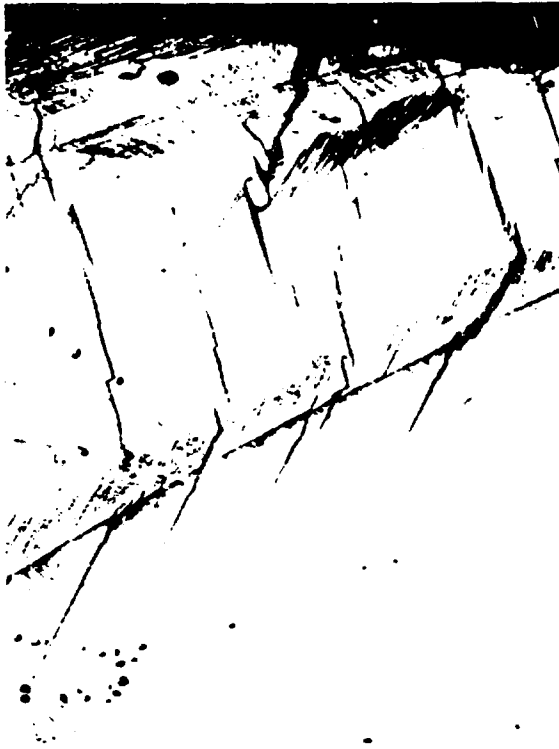
Figure 6. Cracks Nucleating on Surface of Recrystallized Area  
in Fe-20Cr-20Ni 50x.

In some instances a specimen contained recrystallized areas which formed during the final annealing treatment. During subsequent stress corrosion testing, the grain boundaries present acted as nucleating sites for stress corrosion cracks (Figure 6). Upon examination at higher magnifications, it was observed that these cracks actually nucleated from attacked slip lines near the grain boundary (Figure 7).

Figure 6 also suggests strongly the crystallographic nature of the crack plane for the Fe-20Cr-20Ni alloy. Another observation made about some cracks in recrystallized regions is that the crack plane changed direction when crossing a twin boundary (Figure 8). A typical stress corrosion crack as seen in a single crystal of Fe-20Cr-20Ni is shown in Figure 9 which is a composite of two photomicrographs. The large angle made with the tensile axis is especially obvious here.

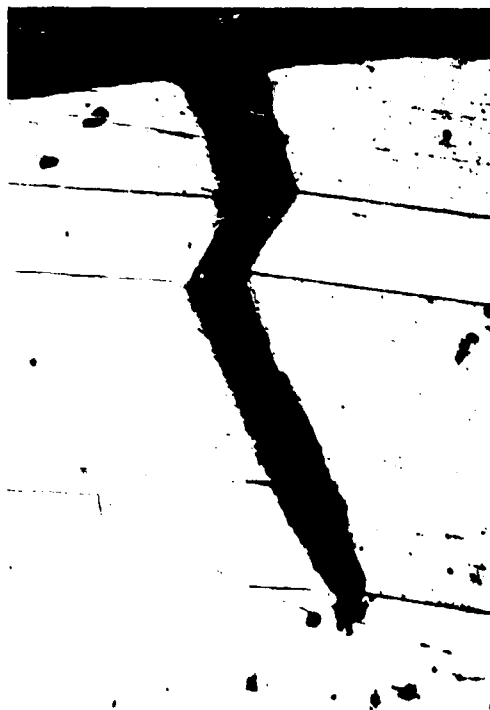
Figure 8. Crack in Recrystallized Area in Fe-20Cr-20Ni Specimen  
160x.

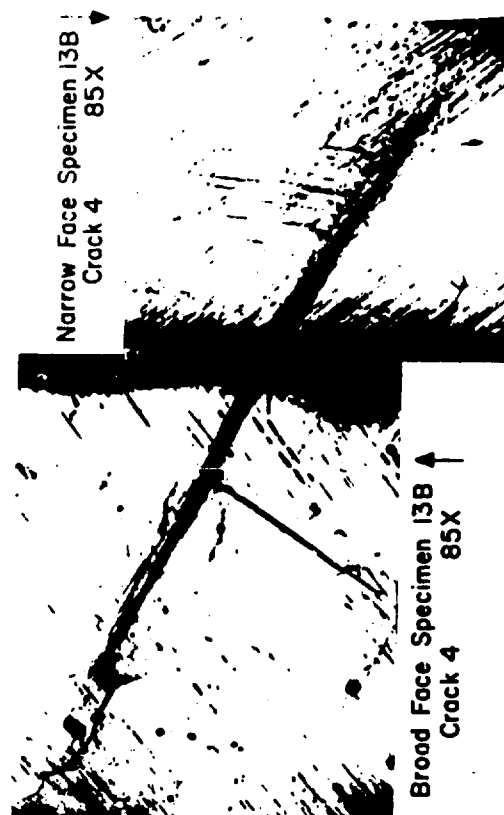
Figure 9. Composite Photomicrograph Showing Typical Crack Trace as Seen on Two Surfaces in Fe-20Cr-20Ni Single Crystal 85x.

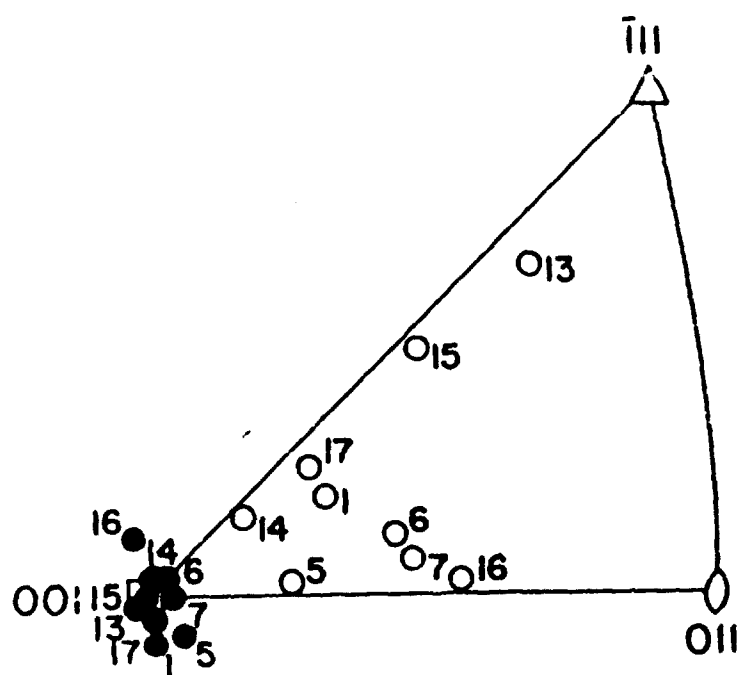
○ Tensile Axis (Fe-20Cr-20Ni)

● Crack Plane Pole (Fe-20Cr-20Ni)

Figure 10. Unit Triangle Stereogram Showing Position of Crack Plane Poles and Tensile Axes for Fe-20Cr-20Ni Single Crystals.

The Fe-20Cr-20Ni alloy was quite different from the Fe-20Cr-12Ni and commercial 304 alloys with regard to the crystallographic orientation of the crack plane. The plane of the stress corrosion cracks in single crystals of Fe-20Cr-20Ni was the (100) plane which had the greatest normal stress upon it. The data illustrating this point are presented in Figure 10. Here the crack plane poles and the tensile axes for

the specimens tested are plotted on the unit triangle. The numbers refer to an ingot number which usually represents four specimens. It is evident that the crack plane poles can be identified within experimental error as (001) type poles in all cases.

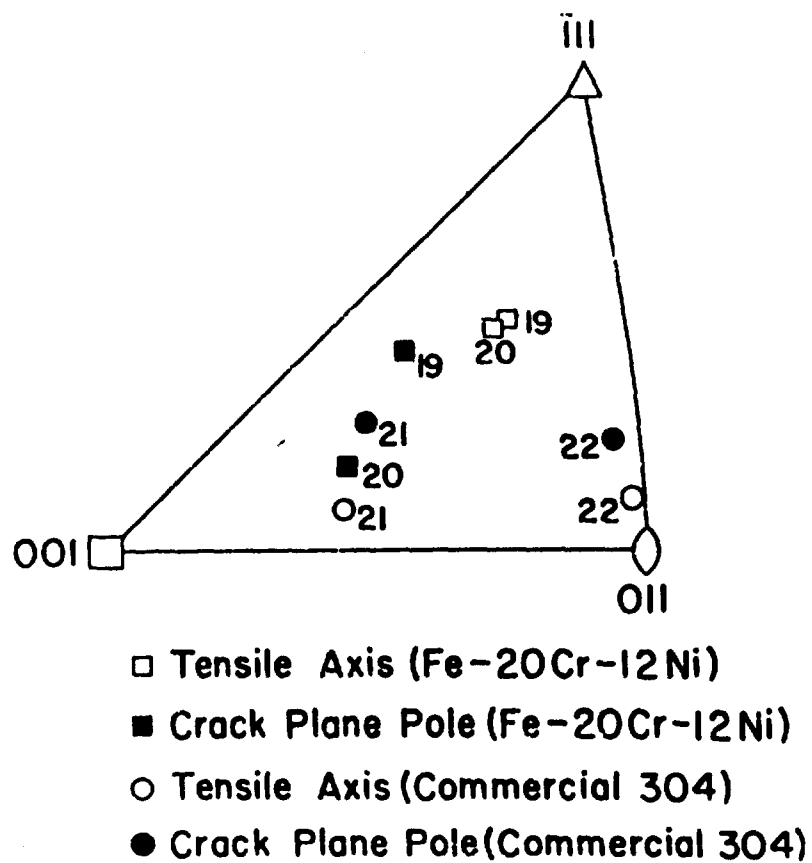
Figure 11. Unit Triangle Stereogram Showing Position of Crack Plane Poles and Tensile Axes for Commercial 304 and Fe-20Cr-12Ni Single Crystals.

The Fe-20Cr-12Ni and commercial 304 single crystals developed cracks which were roughly normal to the tensile axis and unrelated to any crystallographic plane over long distances. This is best shown by Figure 11.
